# KOONTZ-WAGNER REVOLUTIONIZES PREVENTIVE MAINTENANCE WITH ULTRASOUND

# THE POWER OF ULTRASOUND IDENTIFIED PARTIAL DISCHARGE MISSED BY IR TECHNOLOGY

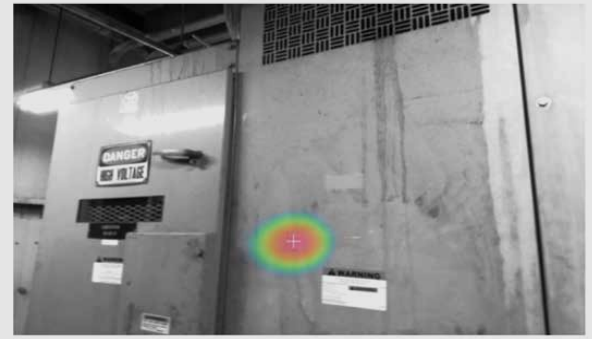
SUB US-A2-3

**Description**  
This is classified as a surface or internal discharge. The discharge appears to be strong and might rapidly escalate to complete insulation breakdown.

| Level | 45.7 dB |

**Recommendation**  
Immediate action. Visual inspection. Clearing of polluted surfaces. Repair or replacement of the components.

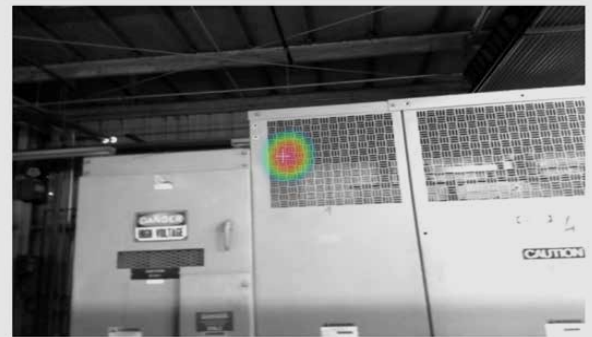
SUB US-A1-1

**Description**  
This is classified as a surface or internal discharge. The discharge appears to be strong and might rapidly escalate to complete insulation breakdown.

| Level | 29 dB |

**Recommendation**  
Immediate action. Visual inspection. Clearing of polluted surfaces. Repair or replacement of the components.

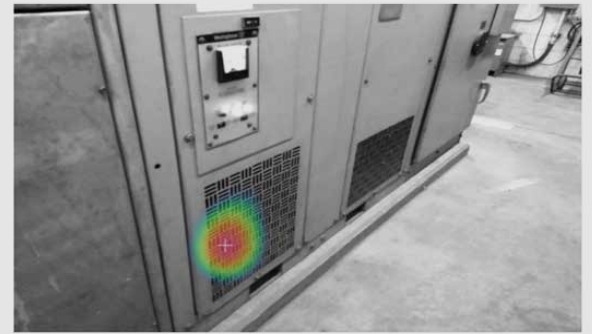
SUB US-B1-3

**Description**  
This is classified as a surface or internal discharge. The discharge appears to be strong and might rapidly escalate to complete insulation breakdown.

| Level | 25.1 dB |

**Recommendation**  
Immediate action. Visual inspection. Clearing of polluted surfaces. Repair or replacement of the components.
