THIS AUTOMOTIVE COMPANY UTILIZED THE POWER OF ULTRASOUND TO MITIGATE OPERATIONAL RISKS AND ENHANCE SAFETY IN THEIR PRODUCTION FACILITY

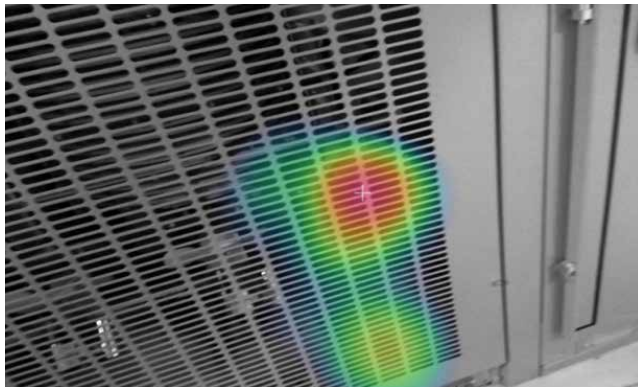
- **Buzzing Sound:** A foreign buzzing sound could be heard from the equipment room, signaling the presence of partial discharge. Using the camera, this buzzing sound was traced back to a transformer within the electrical system.

The UltraView Camera (Si124) report image displaying partial discharge locations on the transformer.

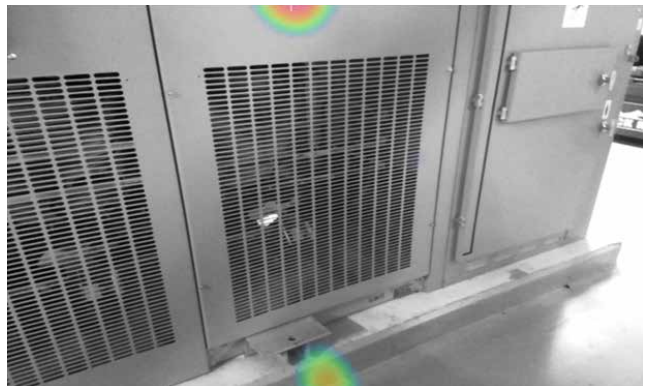
The UltraView Camera (Si124) report after the fix. There is no partial discharge located on the transformer.

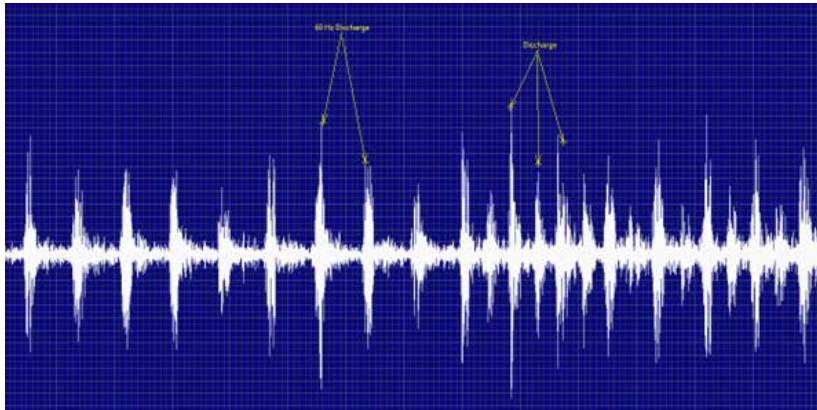
This Time Series shows 60 Hz discharge indicating there is an electrical anomaly. Also, embedded in the sound file are discharges that indicate mechanical movement. From the analysis, the sound file confirms mechanical vibration and electrical discharge. Upon visual inspection by plant personnel, a cable was vibrating on the busbar and confirming electrical discharge at the point of contact of busbar and cable. Solved by separation of cable and reinsulating the wire.

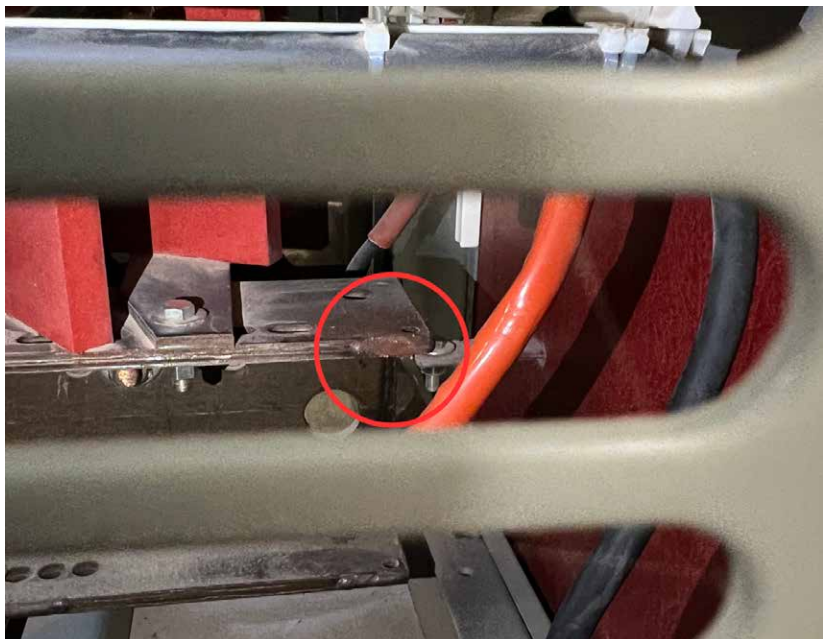
- **Deteriorating Wire:** While investigating the transformer, a deteriorating wire was found leaning against a bus bar, causing the metal to melt together. This posed a severe safety risk, potentially leading to a fire that could disrupt production and safety protocols.

If you look closely, you can see the damage that the wire was causing on the bus bar. The solution was to add additional insulation around the wire to separate it from making contact.
