# 20 HP Motor Ultrasound Analysis CASE STUDY

## CASE STUDY – ULTRASOUND ANALYSIS

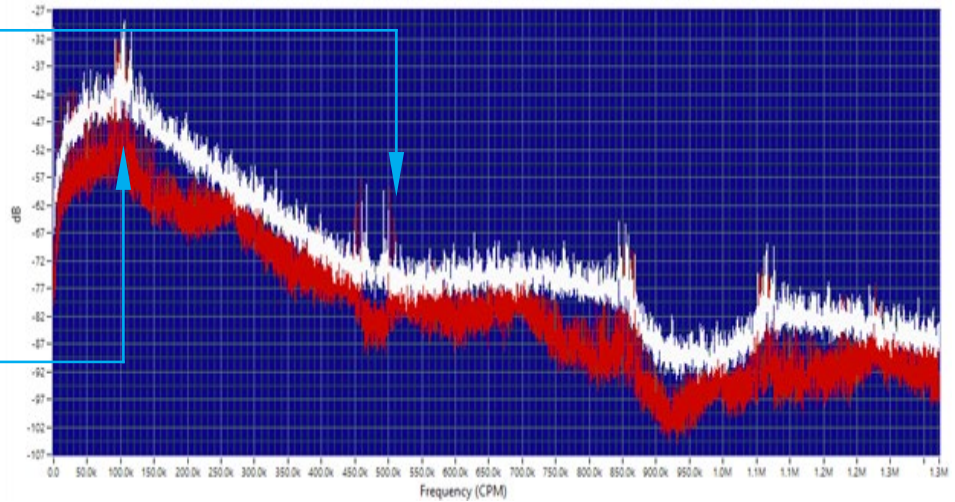
January 2019 data.

In the January 2019 data, the overall noise floor has continued to rise, surpassing the 2018 reading in overall energy level. This is characteristic of a late stage bearing failure, which would warrant an immediate prioritization for repair.

2019 data shows an increase in the raised noise floor indicating a late stage bearing.

"That's exactly what I wanted to hear," said the customer. "After listening yesterday, I thought fluting was the issue. I am ordering grounding brushes for this motor and adding them to the new motor."

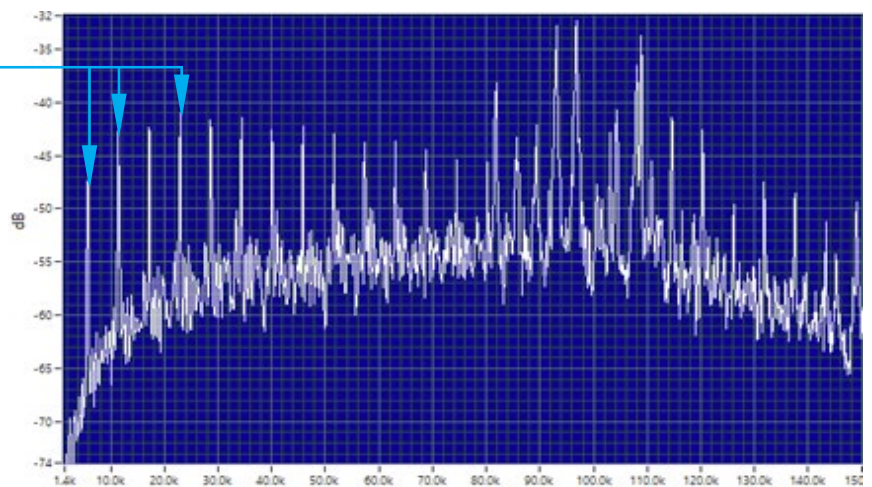
The sound file and graph data from January 2018 is showing multiple harmonics at 5,639 cycles per minute (cpm). The bearing opposite the fan end (6,309) is an 8-ball bearing. Based on that information and the normal operating speed of 1,750 rpms, this would indicate that there is an early outer race bearing defect (5,600cpm for 8 ball bearings) on the non-fan end bearing. While listening to the sound file, there are indications that electrical fluting may have been occurring, which would have then caused the defect.

2018 data showing an early bearing defect with potential signs of electrical fluting found in the sound file.

Bearing Outer Race Fault Frequencies from the January 2018 data. Harmonics of 5635 cpm can be seen; a generic 8- ball bearing frequency is normally 5600 cpm showing that the Non-Fan End Bearing is most likely the cause.
