Electrical Equipment “Screams” For Attention!

Decoding High Frequency “SOS” Calls

*Joseph Gierlach – Vice President, Technical Training and Support
TEGG Corporation ~ Pittsburgh, PA*

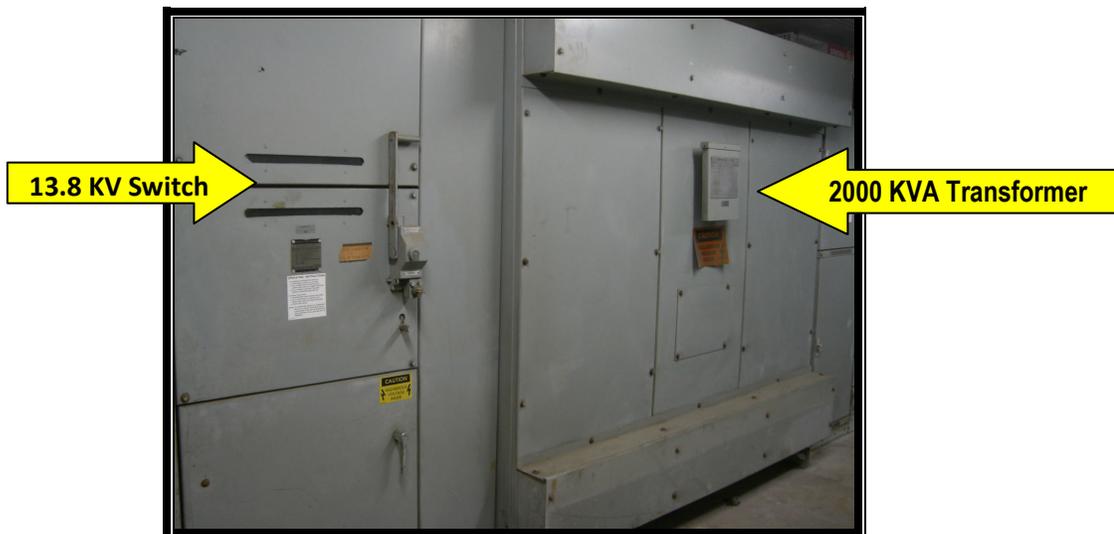
As the inspection progressed, Morgan Fowler, lead technician at this time from Transworld Inc., contacted TEGG Corporation personnel to seek opinions of a recording he had secured on one of the 13.8 KV load break switches. This particular switch was one of two identical arrangements that featured the utility feed, a dry 2000 KVA transformer stepping the voltage down to 480/277 volts for distribution to facility equipment. Additionally, this configuration was mirrored on the opposite side of the electrical room to provide redundant supply in the event of an interruption of either of the unit substations. The image in Figure #1 below gives the perspective of the physical lay-out of the one sub:

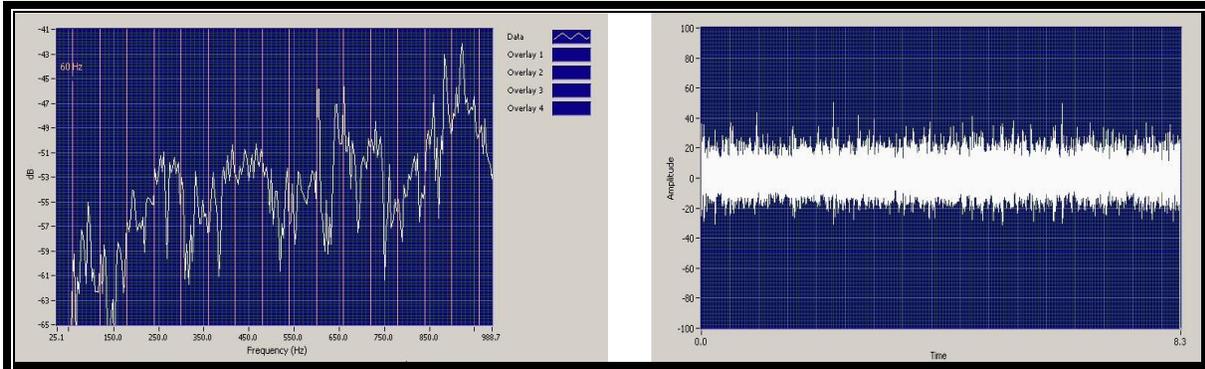
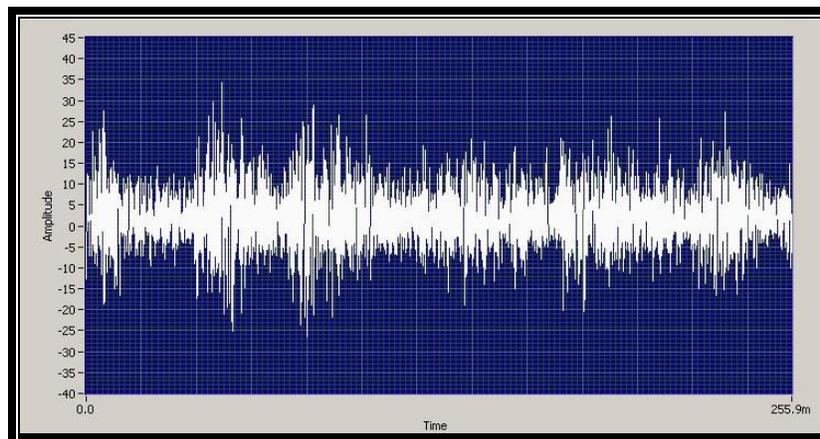
Figure #3

Upon receiving the recordings, and after discussions with Morgan regarding the analysis in the Spectralyzer software, it was determined to be an electrical fault known as “destructive corona”. If you recall from the paper last year at Ultrasound World IV entitled “What you can’t hear can hurt you!”, corona in its natural state is a normal phenomena due to the expanding and collapsing magnetic fields present in systems where voltage levels are >1000 VAC. Corona becomes destructive when the stresses become too large and nitrates are released, mixing with the moisture content in the air, which when combined forms nitric acid and destruction of dielectric insulating systems will begin.

The time domain shows a very uniform, linear pattern in which the excursions from the expected broadband of “white noise” throughout the recording are fairly even in spacing (time) and amplitude. This is due to the fact that the ionization process occurs at the negative peak of each electrical sine wave where the potential is at its highest. The 16 ms time base of 60 Hz AC is very predictable and consistent. With Morgan’s anomaly, it was very similar in nature, as can be seen in the spectrums below in Figure #3, although there were not as many “fault frequencies” in the view. The tonal quality, however, was indicative of an electrical fault, and that was factored into the decisions moving forward.

Here is the “cropped” or “sliced and diced” view of a smaller time frame showing the non-uniform timing and amplitude

Combining the tonal quality, FFT and time domain view, a scope of work regarding possible repair actions was developed and passed up the chain of command at the hospital. Between July and September 2009, frequent visits were made to the hospital for other maintenance needs, and the switch was checked to determine if there was any progression of the anomaly relative to severity.

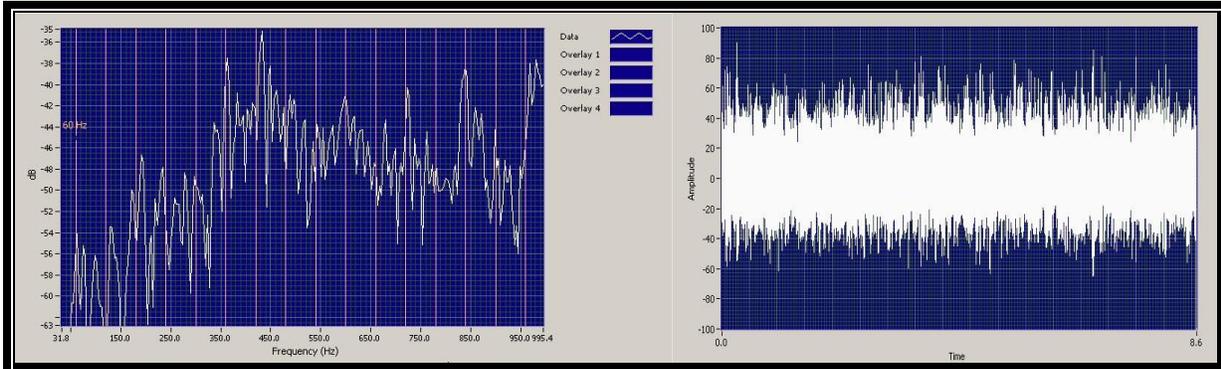
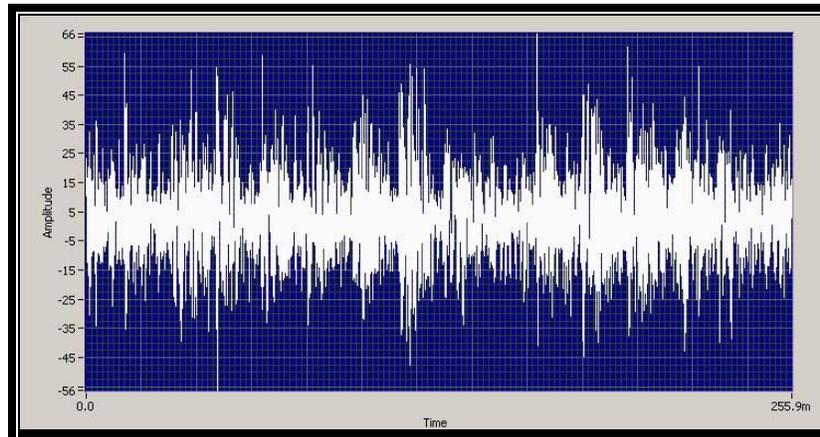
Figure #4

Here is the “cropped” or “sliced and diced” view of a smaller time frame showing the non-uniform timing and amplitude

(Notice the increase in amplitude and frequency of occurrences)

The qualitative differences in the two recordings’ tonal quality, as well as the spectral content, left no doubt in our minds that the deficiency was indeed degrading in severity, and it was only a matter of time before the device would experience a failure.

Armed with this new data on the fault, we prepared and presented a report of findings to the facility engineer, expressing our concern that maintenance must be done, or the switch most likely was going to fail. Obtaining approval for a shutdown in any hospital proves monumental in scope, as the coordination issues to ensure no critical support systems are interrupted have many built-in redundancies that are checked and re-checked. There are no energized types of maintenance tests on this style of switch other than ultrasonic and visual inspections that yield actionable data. Infrared is not effective due to the line-of-sight issues, and there were no infrared windows installed on this unit. (There is a proposal to install these now under consideration with hospital management.)

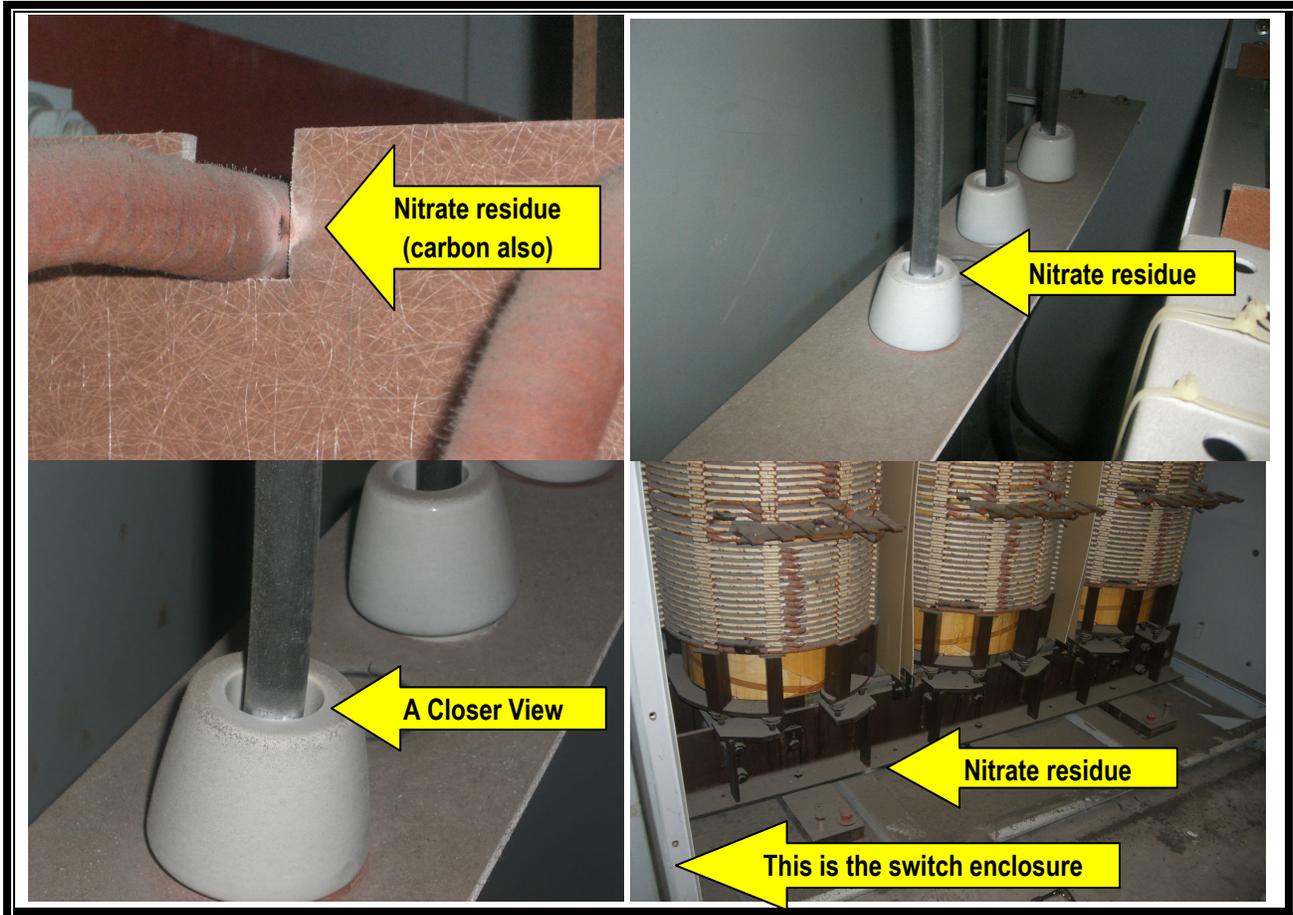
These images illustrate the results of the visual inspection of the switch:

The visual evidence was indisputable and confirmed beyond any shadow of a doubt that the initial and subsequent analysis and suspicions were correct. The switch conductors and insulators were in fact deteriorating rapidly and in need of maintenance. Due to the curtailed allotment for repairs, a complete replacement of the conductors and insulators was not possible during this visit. The customer agreed to allow Morgan to clean the items as much as reasonably possible, work on the procurement of replacement components, and schedule another visit to complete permanent repairs.

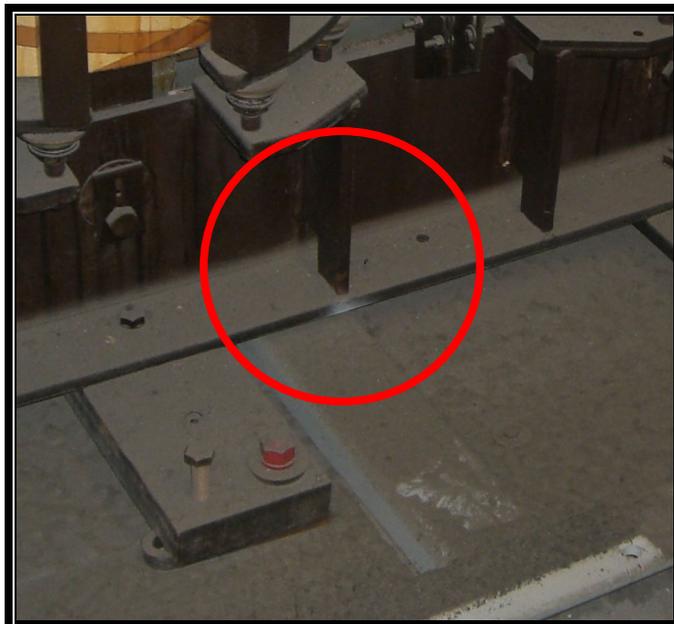
Here is a closer view of the transformer bracket where the nitrates are also visible in the image above:

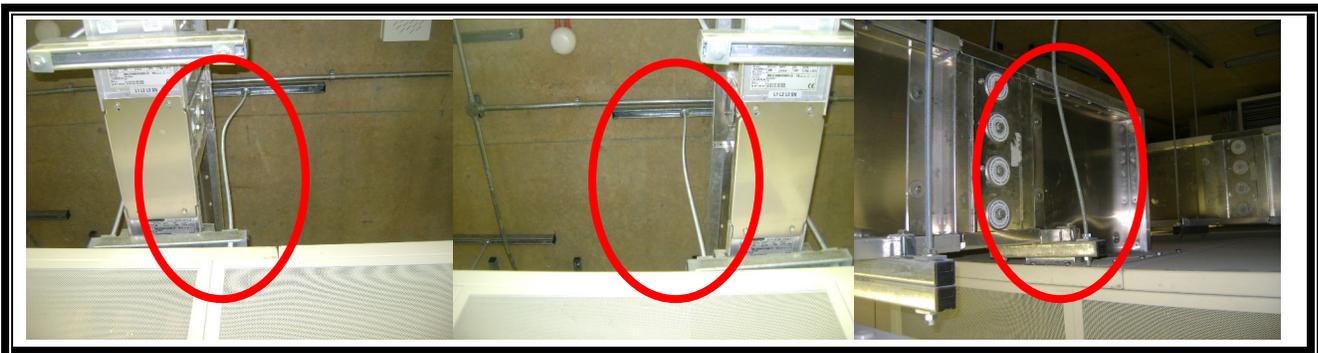
The customer called in the local TEGG contractor due to the equipment apparently experiencing structural movement of some sort, resulting in the bus duct/trunking and supports becoming distorted. This can be seen below in Figure #5 with the visual evidence of movement:

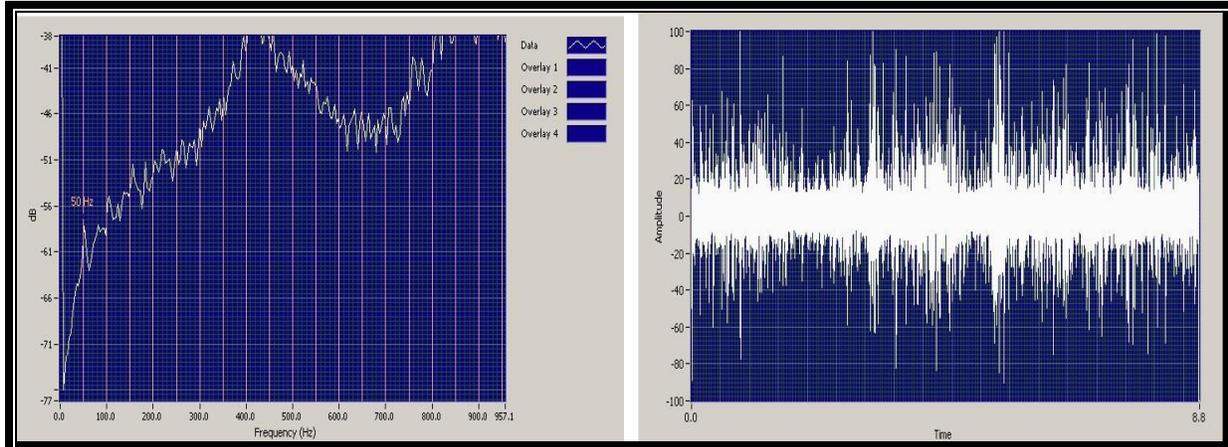
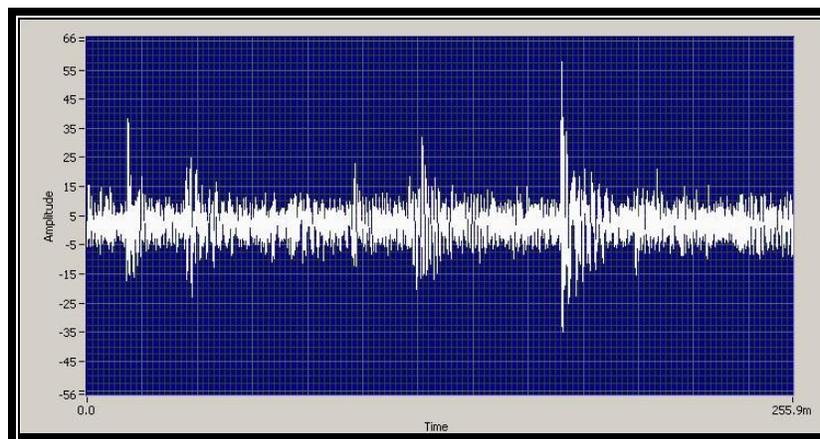
Figure #6

As you can see below in Figure #6, there was not much detail in the FFT, however; the time domain had tell-tale signs of a tracking event:

(Time view sliced)

Frequency analysis had no pattern to discern and notably no fault peaks in the spectrum. The time domain over the 8.8-second recording does have “footprints” of a typical tracking event. This means there are three main factors that distinguish this anomaly:

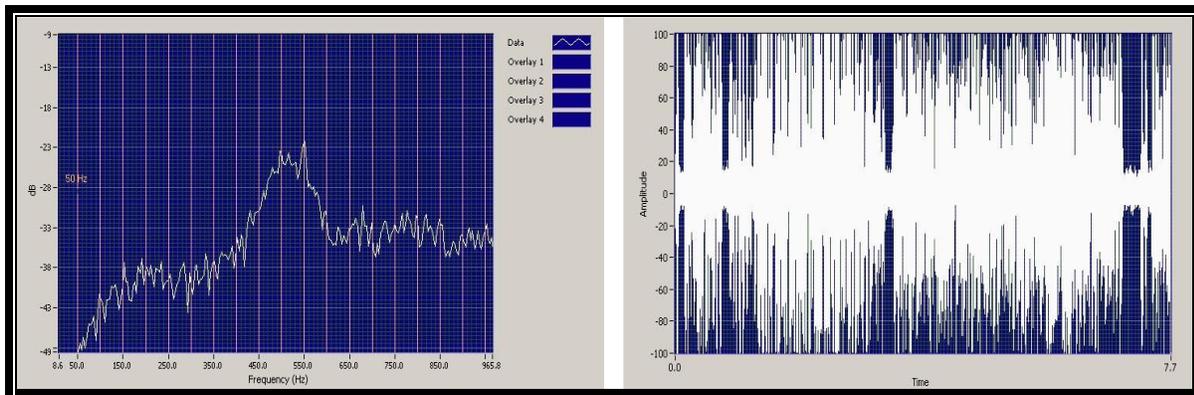
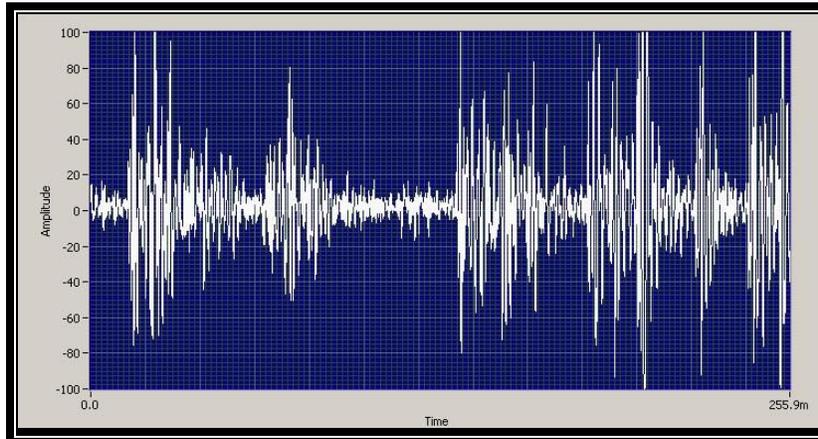
This was very apparent in Mick’s recordings, as the FFT did not represent any discernable footprint that could be linked to an electrical fault. The time domain tells a different story, as it fits the profile of tracking as listed above. A decision was made to come back the following month to see if the condition had further deteriorated. The graphs below indicate what was present in January 2010:

(Again, variations in time and amplitude)

Once again, the FFT spectrum yields any useful data with respect to frequency faults or content. The time domain indicated an increase in the intensity of the discharges while taking the measurements at the exact same location on the unit, with the same attachment, frequency setting, sensitivity setting and environmental conditions. (Noteworthy is the “chopping” of the peaks in the time domain. This is remedied by reducing the sensitivity setting on the instrument to avoid signal overload and square-waved displays inhibiting data analysis.)

This suggests that the anomaly had degraded in nature and became worse from a severity point, which altered the action plan and options. The customer was seeking maintenance and testing records on the unit to aid in developing this plan. At the time of this writing, the outcome is still pending, however, the suspicion is that structural movement of the unit and/or bus bar assembly had placed the low voltage connections under stress and possibly damaged the internal structure of the transformer insulating system. This scenario would almost certainly lead to an arcing/tracking event due to compromised insulation and allowing voltage discharges to occur. Results of subsequent testing and inspections will be forthcoming in the near future.

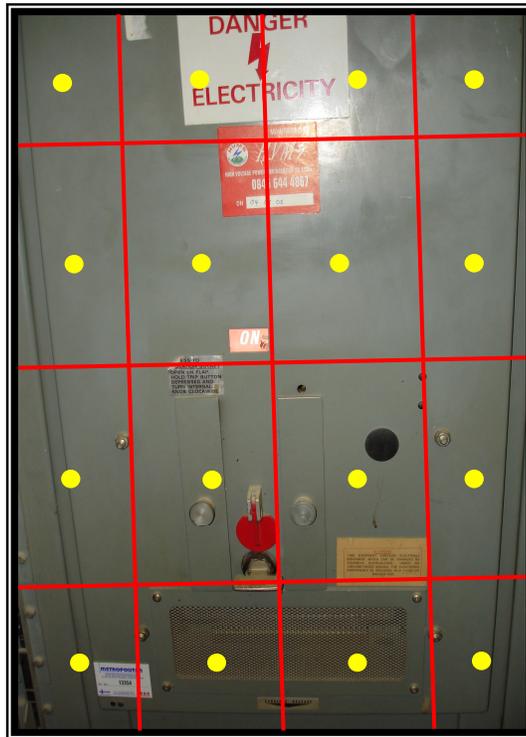
Several positions were selected physically on the exterior of the device to utilize the contact module. An emission was detected, and the recommended procedure of quadrant testing was followed to determine the highest intensity of the anomaly. Below is a picture of the circuit breaker in question, as well as the quadrants from which measurements would be obtained:

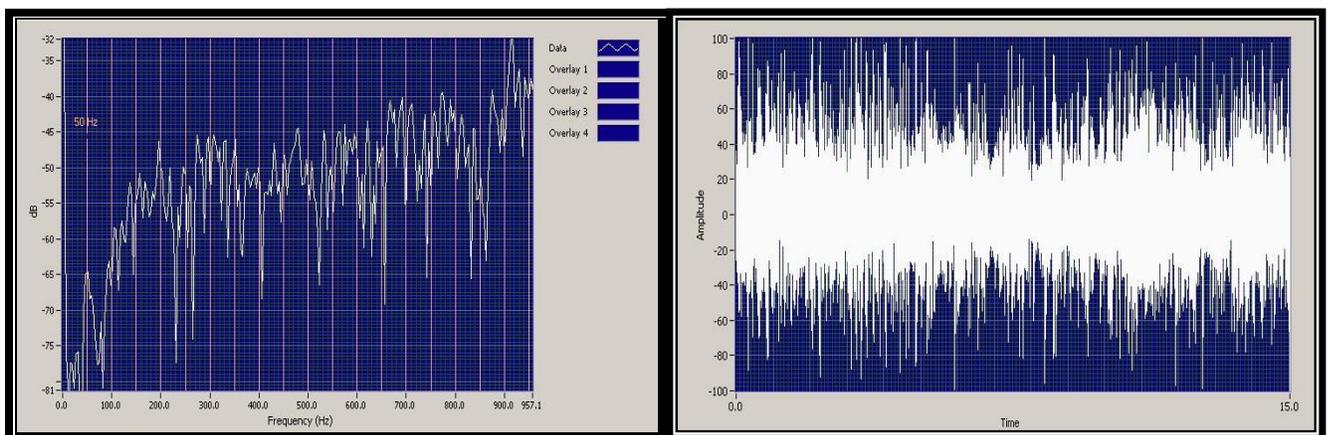
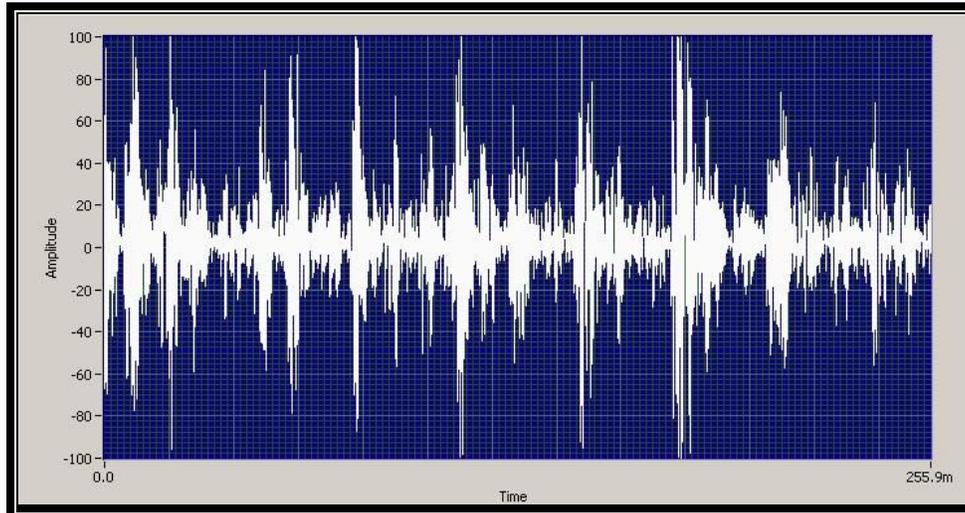
Below are the spectrums generated from the recordings where the signal intensity was highest, in this case near the bottom of the device where the ventilation screen is located:

(Here once again the illustration of non uniform timing and amplitude)

The FFT this time indicated some degree of frequency faults present at the 50 Hz harmonics, including a greater abundance of activity within each harmonic (frequency noise content). The time domain also had the characteristic “footprint” one would be in search of relative to a tracking event. The broadband of white noise throughout the recording was accompanied by non-uniform time and amplitude of electrical discharges. This again reinforces the theory that arcing and tracking *cannot* be identified without the use of both FFT and time domain analysis. The FFT tool allows us to determine if it is electrical or mechanical in nature, where the time domain tool tells the real story as to which electrical event we have taking place.

Based on the fact that analysis revealed a high probability that tracking was occurring somewhere in the circuit breaker, planning is in place to perform a closer, more detailed inspection of the circuit breakers and bus connections this August during a scheduled shutdown of the facility. Efforts are also under way to procure a replacement breaker to be retrofitted and installed at the same time.

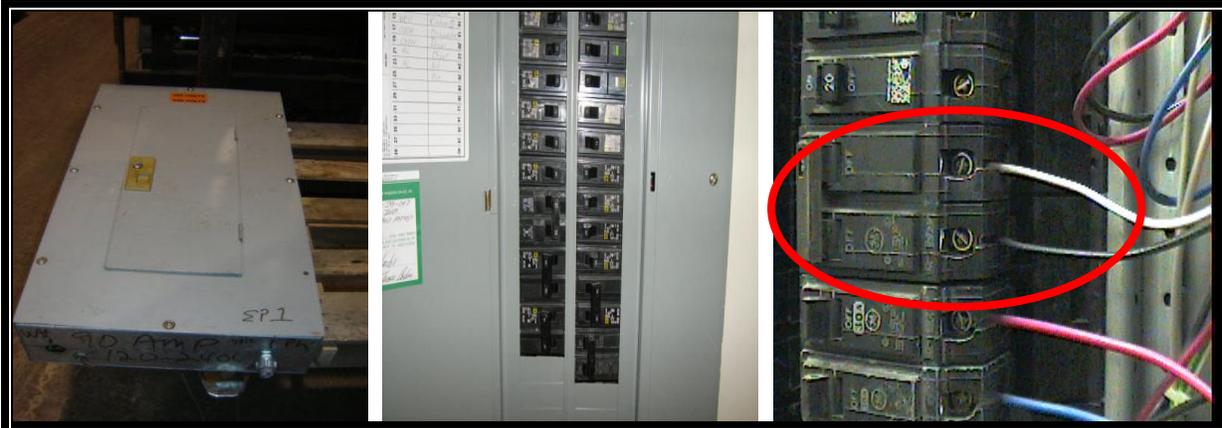
He described a sound in the acoustic isolators (you know them as headphones) that he felt should not be present. The "snap, crackle, pop" characterization came to mind, and he immediately allowed his thought process to drift to tracking as the suspect. The next step was to make a quality recording of the emission and download it to the laptop computer where it could be analyzed with Spectralyzer. Any component that shouldn't have an emission or a tonal quality concern on those that do have some type of ultrasound warrants analysis right there in the field when it is located. An image of the panel type and the actual circuit breaker is seen below:

Aside from the fact that there was a code violation with the use of a "white" conductor as a current-carrying conductor, the ultrasonic emission was cause for alarm. Although one would not believe a simple 30 amp double pole breaker is important enough to justify the efforts, one must take into consideration and investigate what load is served with a given circuit. In this case, the circuit was found to be supplying a central air conditioner unit. But this was not a unit simply for comfort - it serviced the data center in the facility to ensure proper ambient temperatures for operation of the computer networks. This fact added credence to the need to analyze correctly. Once loaded into the software, all the earmarks of a tracking event reared its head. The illustrations below demonstrate once again how both tools clearly expose what is taking place and remove any doubt:

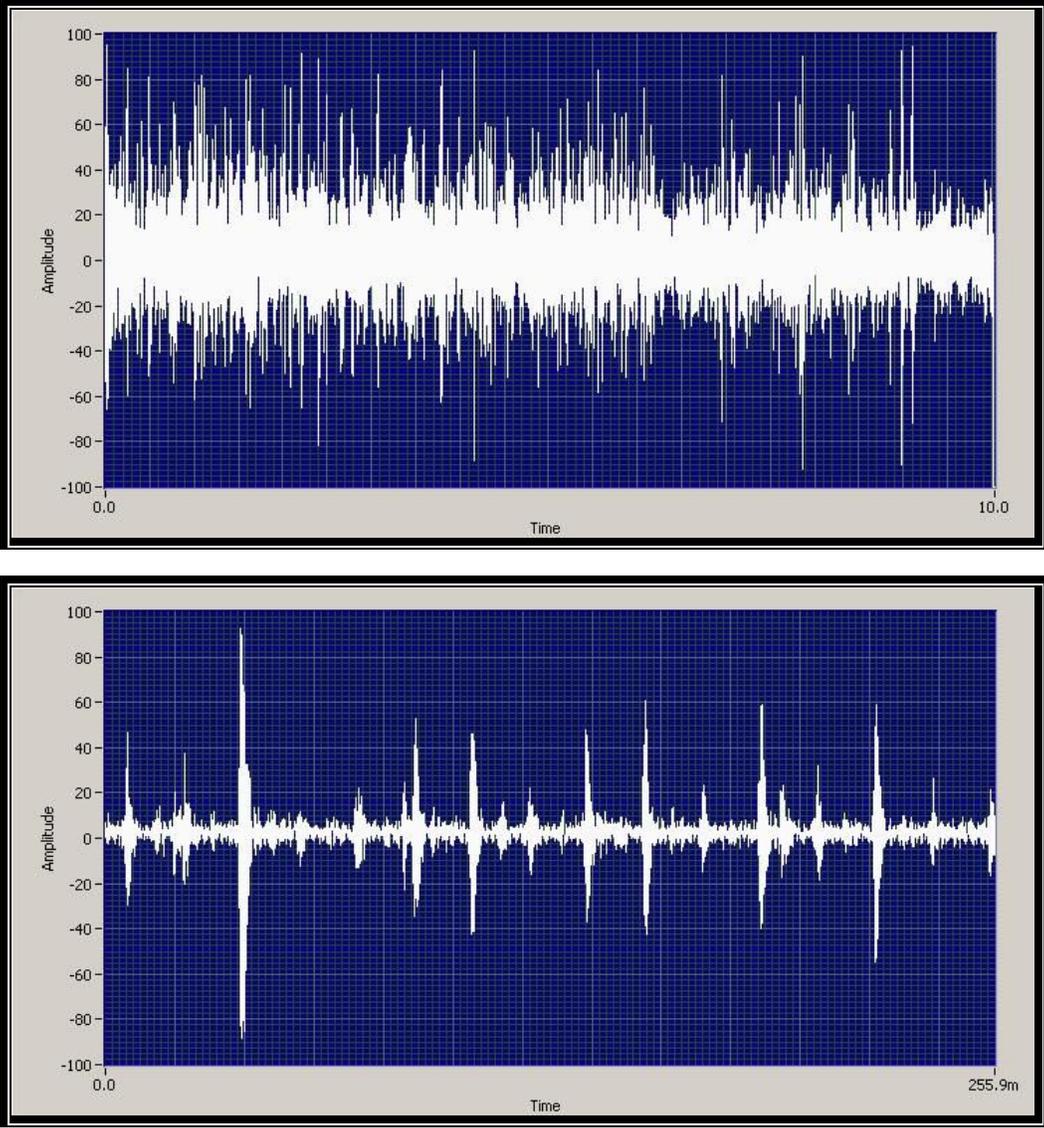
The respective time domain graphs are the proverbial “icing on the cake” for the analysis. All the hallmarks of an electrical tracking event manifest with great clarity and solidify identification of this fault, which degrades with each passing day. The first graph is the entire 10 seconds of recorded tracking, the second a snapshot at the 4-second mark:

(Great visualization of the footprint exhibiting total non-linearity)

The intriguing aspect of the above two views relates to the method in which tracking discharges take place along the entire 360-degree electrical cycle. If you recall from Example #2 in which tracking was graphically portrayed, these discharges occur anywhere on a given electrical cycle. As the discharges become more frequent (ergo more severe in nature), you will see the number of excursions increase and become more compacted, suggesting greater numbers of tracks per cycle. This is clearly evident in the first image above displaying the full 10 seconds of recording time.

The second image is a 255 millisecond slice to demonstrate a “magnified” view of this concept. Notice that both the amplitude and spacing of the discharges have no distinct pattern, meaning the intensity and timing are non-linear and present throughout each electrical cycle. Clearly and without reservation, this breaker was deemed to be in the failure mode due to the tracking taking place internally, and was recommended for replacement to avoid a future interruption. The outcome relative to repairs is still pending. The results of the inspection were already presented to the customer, and they will ultimately decide which direction to proceed and with whom. Certainly the customer cannot dispute the value received by this service, professionalism exhibited by the technicians in the application, and the final product report outlining all deficiencies. This is what “service” should be about.
