Ultrasonics Plays Key Role in Nuclear Generating Station's PdM Program

By Stephen L. Hofmann PE, Rotating Equipment Reliability Engineer, Palo Verde Nuclear Generating Station

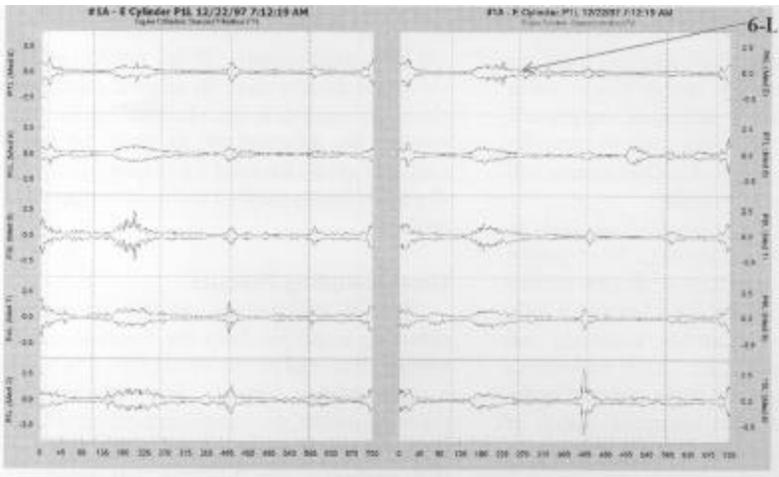
Engine 1-A Sticky Intake Crosshead

Figure 3 shows a set of left bank standard vibration signals taken on the Unit 1A Emergency Diesel Generator. The number "six-left" cylinder had an exhaust crosshead roller pin failure, however the roller was still functioning. If you look closely at the number 6-L trace in the figure, there is an anomaly in the signal slightly before the valve closure event which the team thought was due to crosstalk from the number five-L cylinder.

When we used the "marker" view to look at the anomaly, the spikes lined up with combustion noise from five-L so we did not suspect a problem. We also had a similar undetected broken exhaust crosshead roller problem on the other engines. After several of these missed opportunities, we performed a formal root-cause-of-failure investigation, and decided to

Note: No obvious anomalies present in the standard VT4 signal

Figure 3 - A set of left bank standard vibration signals from Unit JA Emergency Diesel Generator.

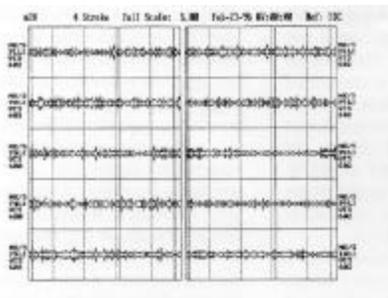
Original Ultrasonic Signal Not Adequate

Clearly, the signal was not tuned for crosshead rubbing. After several engine crosshead missed opportunities, this test point was abandoned. The reason the original ultrasonic system did not produce good signals is because there was not a gain and frequency custom adjustment. Figure 6 shows the ultrasonic trace from the LJE probe using the Recip-trap VT4 setup. An anomaly around the intake valve closing event on the Six-L cylinder revealed itself. During the engine overhaul outage, the head was pulled and the DG Team discovered that an area about the size of a quarter on the crosshead had no clearance and on one spot there was some minor galling. The clearance between the crosshead and its guide was increased back to specification and the galling was removed. The crosshead was reused. In the post-outage engine analysis, the anomaly seen in the before outage ultrasonic trace had disappeared.

.Original VT5 probe was too uniform
.No definition in Signal with events

Figure 5 - The signals from the original 9220 ultrasonic probe.

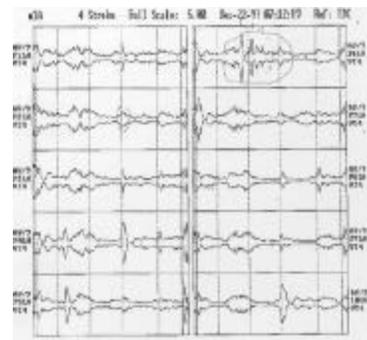
Engine 1-A Sticky Intake Crosshead

symptom

Irregular ultrasonic trace around intake closing event of 6 -L

Figure 6 - The ultrasonic trace from the UE probe using the Recip-trap VT4 setup.
