EARLY INTERVENTION WITH THE ONTRAK WIRELESS: EXCESSIVE GREASE CONSUMPTION IN HIGH-HEAT MANUFACTURING ENVIRONMENTS

GREASE CONSUMPTION AS A KEY INDICATOR IN EXHAUST FAN BEARINGS

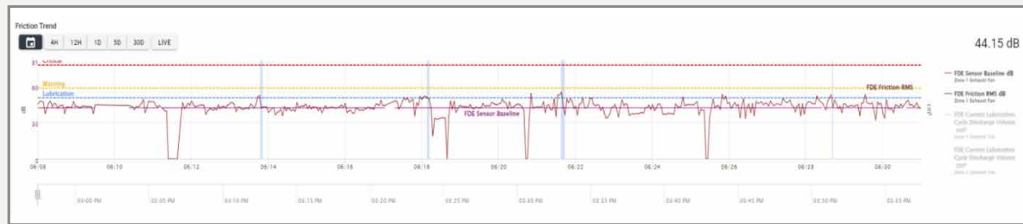
Drive-End Bearing (Figure 1A):

Consumed just 2 cc of grease over the month.

Figure 1A - Exhaust Fan Drive End Bearing Friction (Ultrasound) Trend. The blue vertical bars indicate lubrication events, showcasing how friction levels fluctuate in response to each lubrication instance.

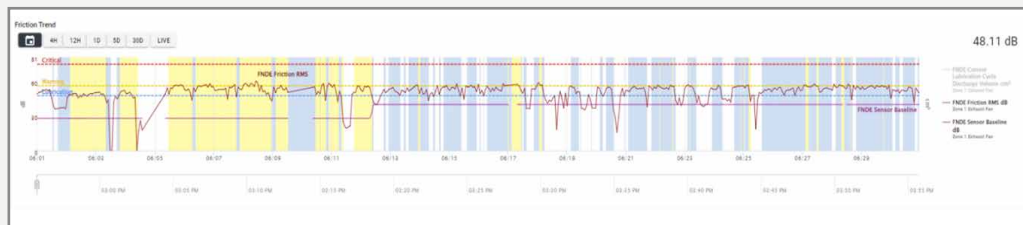
Non-Drive-End Bearing (Figure 1B):

Consumed a concerning 22 cc of grease during the same period.

While some variation in grease consumption is normal, this level of disparity was a red flag. The system's data showed that the non-drive-end bearing was struggling, consuming far more grease than expected to maintain its friction levels.

Figure 1B - Exhaust Fan Non-Drive End Bearing Friction (Ultrasound) Trend. The blue vertical bars indicate lubrication events, showcasing how friction levels fluctuate in response to each lubrication instance.

Upon further investigation, the maintenance team discovered that the recently replaced non-drive-end bearing had developed looseness. Traditional vibration analysis had not triggered any alarms, but ultrasound technology detected subtle signals at 1x RPM, indicating early signs of bearing wear. These minor signals, combined with the excessive grease consumption, confirmed that there was a developing issue.

The OnTrak Wireless system's autonomous tracking of lubrication needs, combined with grease consumption data and friction trends, enabled the maintenance team to identify and address the issue before it escalated into a full-blown failure. By catching the issue early, they avoided costly downtime and reduced repair expenses.
