HARNESSING THE POWER OF ULTRASOUND: ONTRAK WIRELESS DETECTS BEARING FAULTS EARLIER THAN VIBRATION MONITORING IN RECIRCULATION FANS

MONITORING A RECIRCULATION FAN'S NDE BEARING WITH THE ONTRAK WIRELESS

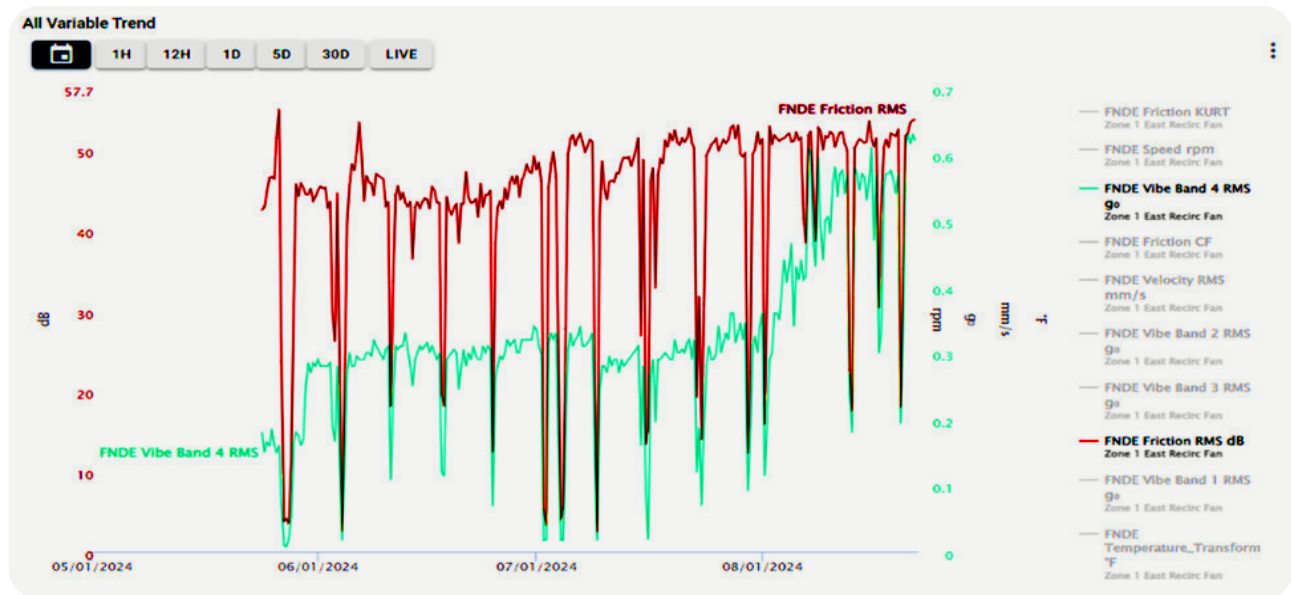
From the start of operations, ultrasound data indicated that friction levels on this bearing were consistently higher than those of similar bearings. Over time, friction levels gradually increased, eventually reaching the second alarm level despite multiple lubrication attempts. The OnTrak Wireless system's ultrasound monitoring detected a clear, upward trends in friction levels, but lubrication efforts did not return friction levels back to baseline, suggesting a deeper underlying issue.

To compare the early detection capabilities of ultrasound and vibration monitoring, the team tested when traditional vibration sensors would detect the issue initially flagged by ultrasound. Despite rising friction levels, the vibration data remained stable. **It wasn't until one full month later** that vibration acceleration began to increase, finally triggering a vibration alarm and indicating a developing mechanical fault.

This case study highlights the clear advantage of ultrasound monitoring in detecting bearing issues earlier than traditional vibration monitoring. The OnTrak Wireless system provided a critical early warning by detecting rising friction levels in early July, giving the team time to investigate and address the issue before a mechanical fault developed, which vibration acceleration only indicated one full month later.
