# REPAIRING RADIANT HEATING—AN EFFECTIVE METHOD

Roland Reisley

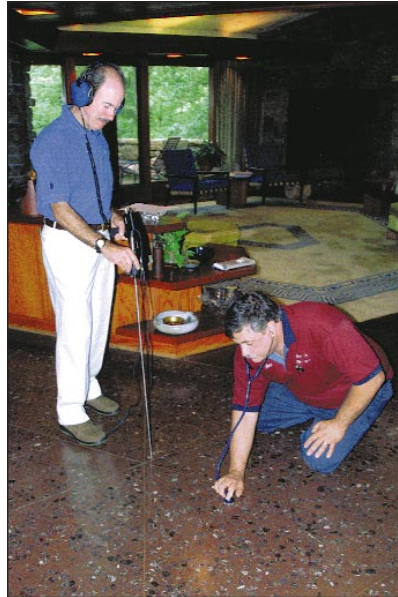
Joining our plumber expert, Mark, Alan moved the “Ultraprobe” around the suspect area [Figure 1], stopping at the loudest point. Mark “attacked” at that point [Figure 2] and soon uncovered the leak. It was in a bend, perhaps a weakened stress point. [Figure 3] The pipe was replaced, surrounded with gravel and covered with concrete to an inch — below the surface leaving room to replace the terrazzo. [Figure 4] Correctly locating the leak limited damage of the floor to a single module — and the heating system is working perfectly.

Fig. 1. Searching in the suspect area.

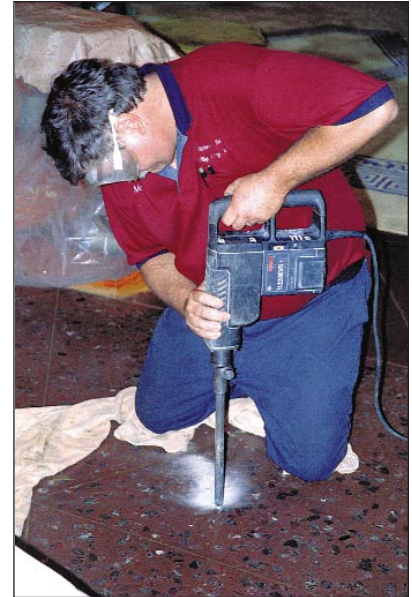
Fig. 2. Breaking in.

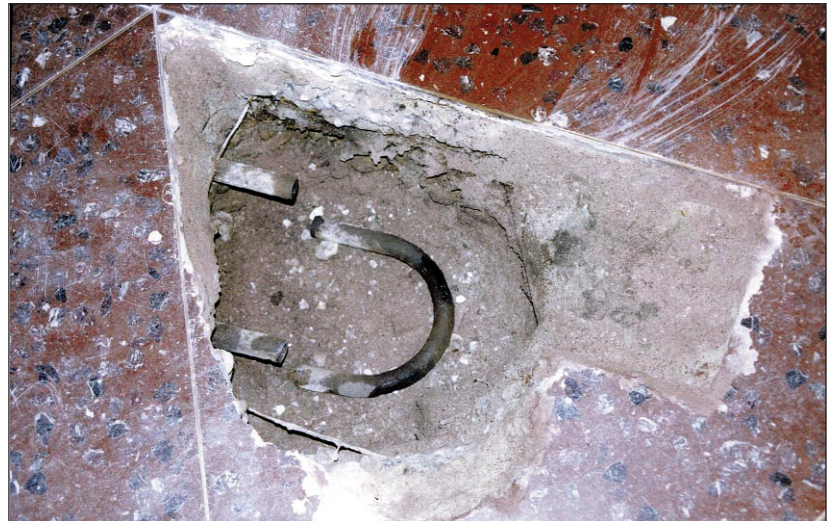
Fig. 3. The bend that leaked (external corrosion).

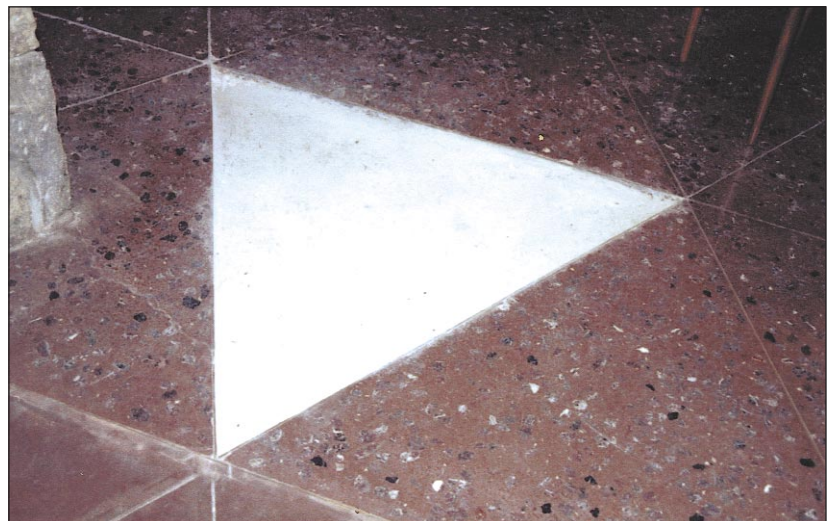
Fig. 4. Accurate location limited damage to a single module.
