Slow-speed bearing failure detected using ultrasound

Slow speed bearings produce low levels of ultrasonic noise - but an ultrasound instrument can still reveal faults by allowing the bearing's signature in the audible frequency range to be analysed.

Using ultrasound to identify oven motor bearing failure

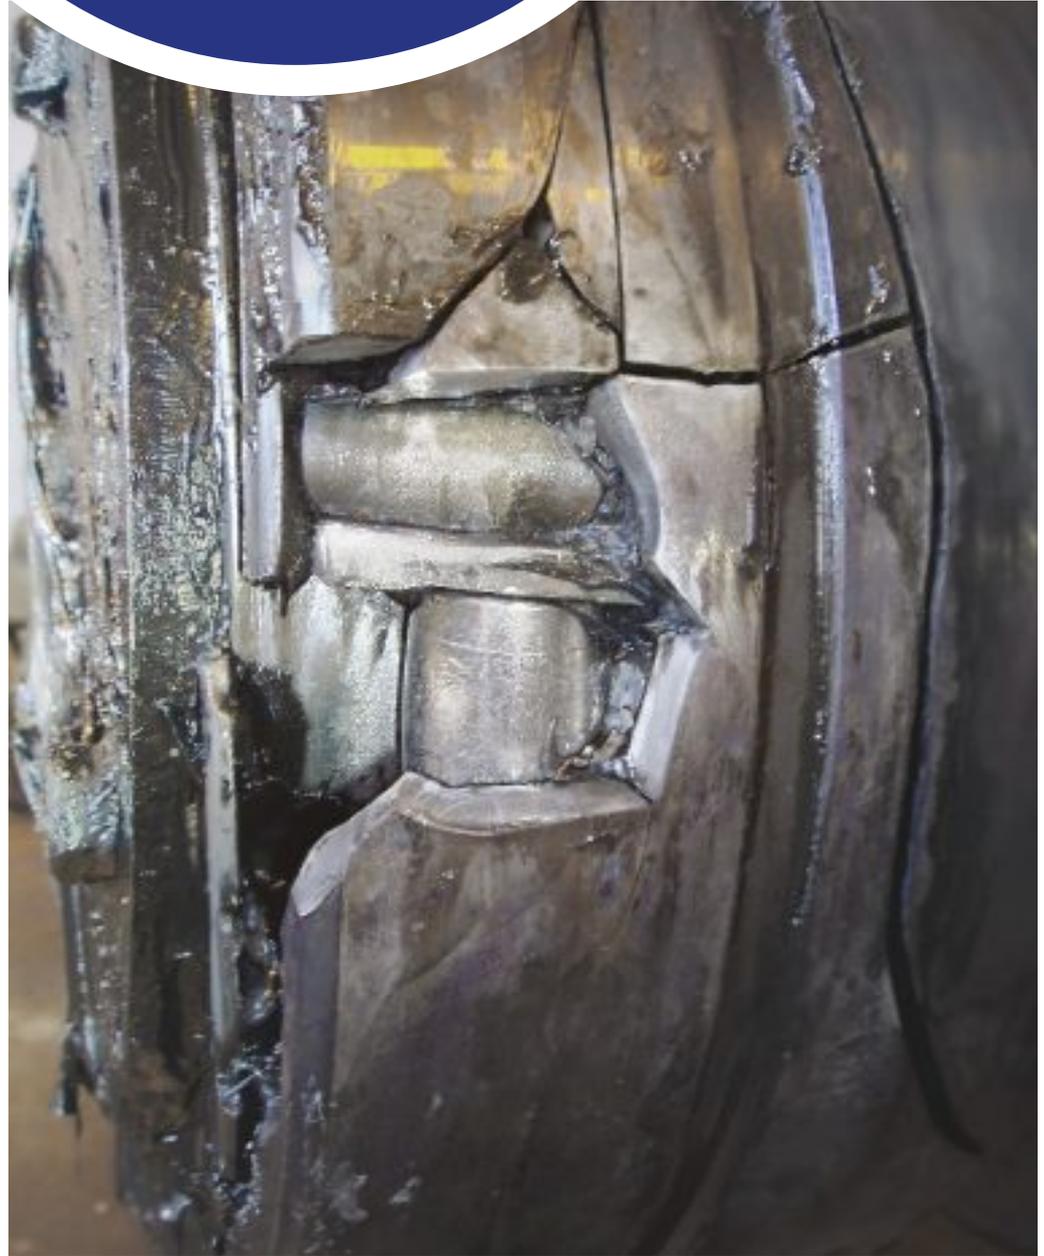
Slow speed bearing damage detected with ultrasound p4

After the ultrasonic inspection, a grease sample was taken to confirm whether there was any damage on the bearing. The results of the analysis showed the presence of metal particles, confirming damage as indicated by the ultrasound instrument.

The next step was scheduling an outage to replace the bearing, which was in very bad condition. Part of the outer race came away as it was opened. It was also noticeable that one of the rollers had moved through 90°. The cage had been badly damaged too.

The spectrum analysis of this oven motor bearing (left) shows clearly where the roller at 90° hits the crack, as the knock stops briefly. Thus the sound pattern indicates an existing problem, being the most reliable source of information when determining the condition of a slow-speed bearing.

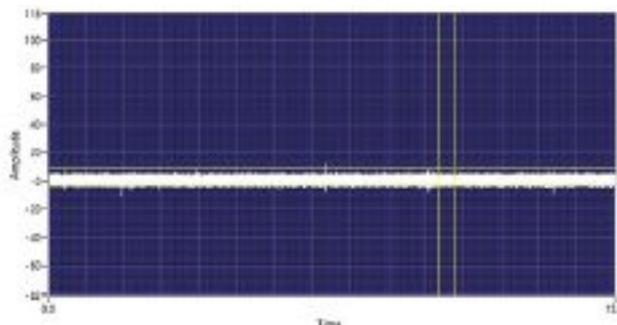
Good motor bearing

In that case, it is important not only to listen to the sound of the bearing, but more importantly to analyse the recorded sound file using spectrum analysis software, focusing on the time waveform to see if there are any anomalies present. If "crackling" or "popping" sounds are present, then there is some indication of a deformity occurring. In bearing speeds above 25rpm, it is possible to set a baseline decibel level and examine the trend of the associated decibel level readings over time.
