Electrical Equipment “Screams” For Attention!

Decoding High Frequency “SOS” Calls

*Joseph Gierlach – Vice President, Technical Training and Support
TEGG Corporation ~ Pittsburgh, PA*

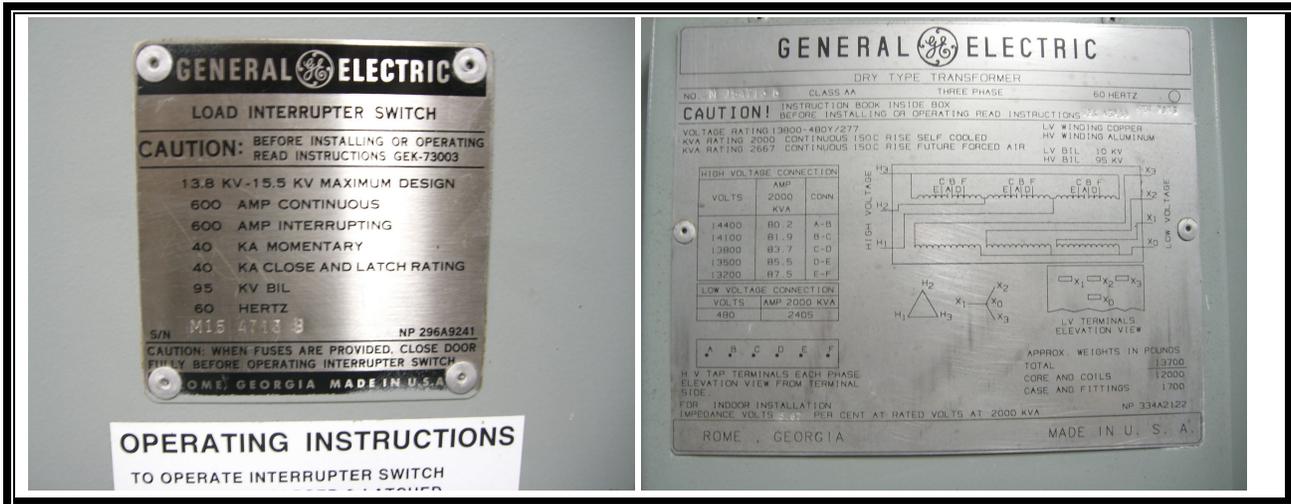
As the inspection progressed, Morgan Fowler, lead technician at this time from Transworld Inc., contacted TEGG Corporation personnel to seek opinions of a recording he had secured on one of the 13.8 KV load break switches. This particular switch was one of two identical arrangements that featured the utility feed, a dry 2000 KVA transformer stepping the voltage down to 480/277 volts for distribution to facility equipment. Additionally, this configuration was mirrored on the opposite side of the electrical room to provide redundant supply in the event of an interruption of either of the unit substations. The image in Figure #1 below gives the perspective of the physical lay-out of the one sub:

(Directly opposite of this is an exact duplicate configuration of the illustration above.)

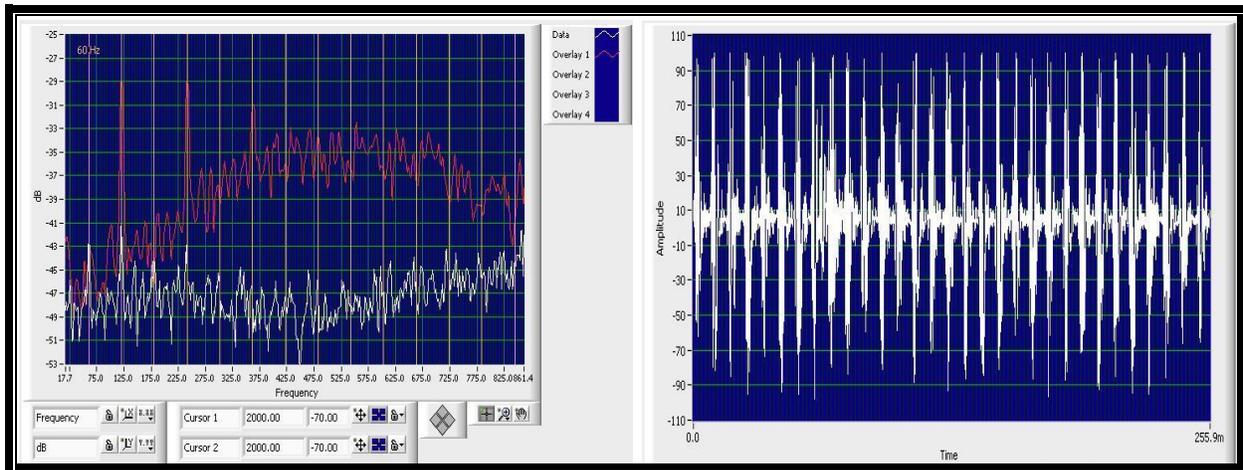
Figure #2

Reviewing what “destructive corona” looks like using the FFT and time domain tools in the Spectralyzer software can be seen below in Figure #2:

The white trace in the FFT illustration is the known sample of destructive corona, and in the time domain on the left, the same event is displayed. FFT demonstrates pronounced 60 Hz “fault frequencies” only in the beginning part of the spectrum, with a drop-off as it moves further along the spectrum. This is unlike “nuisance” corona in which the 60 Hz “fault frequencies” are predominant throughout the spectrum. Both instances of this type of corona will also have an abundance of noise content in between each harmonic frequency.
