Ultrasonics Plays Key Role in Nuclear Generating Station's PdM Program

By Stephen L. Hofmann PE, Rotating Equipment Reliability Engineer, Palo Verde Nuclear Generating Station

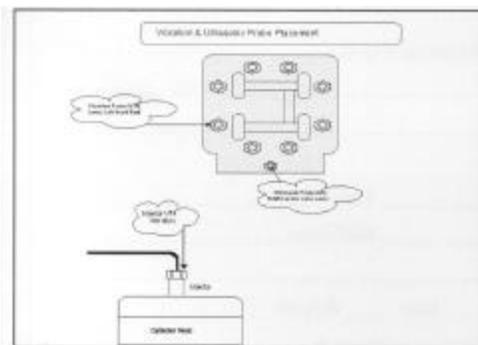
Figure 1 shows the location of the vibration and ultrasonic test points on the cylinder head. A technician attaches a standard vibration accelerometer on the lower left cylinder head stud, which is accessed by removing the valve train inspection cover. The other two test points on the cylinder head are taken on the injector with the accelerometer and on the lower center valve cover cap screw using our handheld ultrasonic instrument and its contact probe. Our technician sets the probe with the gain knob at 5.0 and the frequency range knob at 70 kHz. The ultrasonic test point is taken on the center valve cover cap screw because after many months of trial and error, it tends to be centered over the intake and exhaust crosshead/ roller assembly and gives the best signal for crosshead rubs. Problems with crosshead rubs are believed to be

Figure 1 - The location of the vibration and ultrasonic test points on the cylinder head.

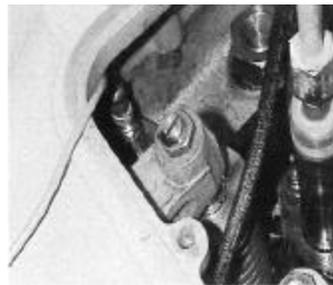
Figure 2 - The accelerometer on the lower left head stud with the inspection cover removed, and the accelerometer on the injector nut with the inspection cover in place.
